Test Report

No.: 64.190.24.0113.01-00

1	Product Description	Portable Stage	
2	Dimensions	Overall Dimension:	1.22m L x 1.22m W x 840mm H
		Frame & transom:	Aluminum Transom&steel layer truss
		Panel (mm):	Laminated plywood T60, non-slip
		Leg profiles:	Dia. 50 x T 3.0 & Dia. 25 x T 1.5

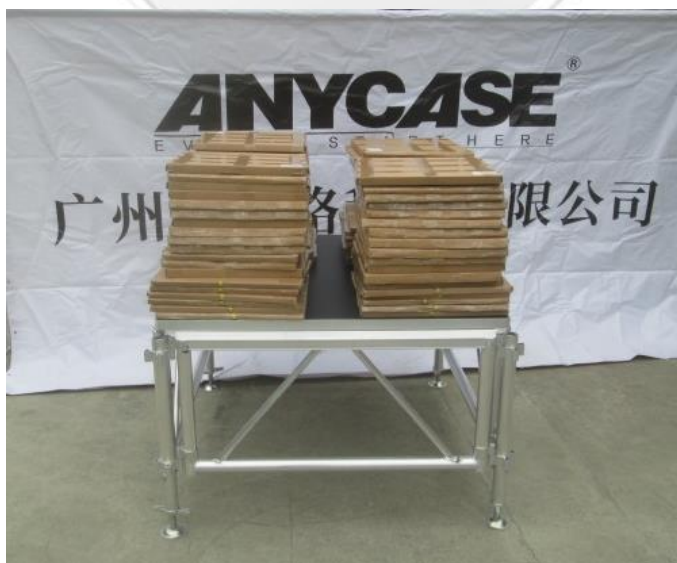
TESTING PHOTO

Test item	Requirement ~ Test	Measuring result ~ Remark	Verdict
Loading test	<p>The specified loads were applied and observe any damage under this loading condition.</p> <p>1. Uniformly distributed load (UDL) The stage was supported by four poles at four ends. A specified nominal load was uniformly distributed on the stage according to Figure 1.</p>

Item	Test Data
Surface Area, (m ²)	1.48
Uniformly distributed load, (kg)	1150
Test results	No visible damage was found during and after test.
